How system level noise in digital interfaces can lead to spurious errors in serial flash memory

15-03-2020

Authors: Paul Hill, Gordon MacNee

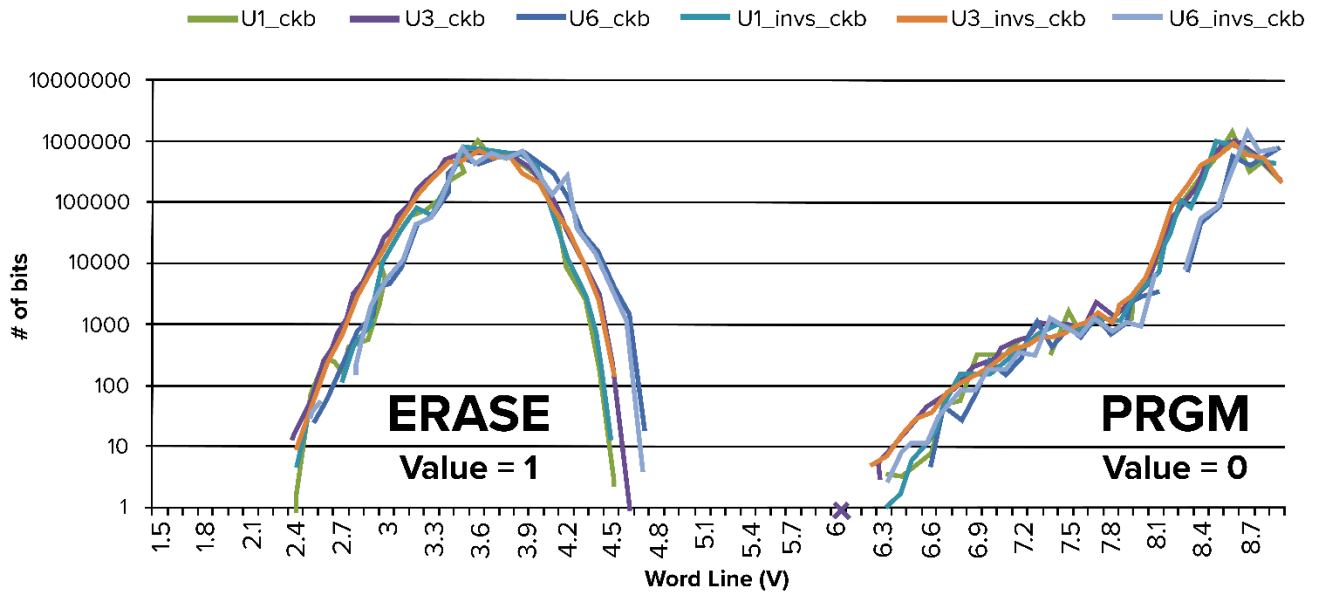
As an example, consider the image in Figure 1. It shows healthy cell margins for six flash devices. Two distinct patterns (lobes) emerge between cells programmed with data representing logical 1 (2V to 5V) and 0 (>6v). In Figure 1 there is good separation between the left and right lobes. By comparison, the image in Figure 2 shows memory cell margin for three flash devices that have suffered data corruption caused by noise (overshoot and undershoot) on the control lines. There is no separation between the lobes and the memory cells values for 1's and 0's begin to merge

Figure 1: This image shows good cell margin separation data for flash memory that has been programmed and erased.

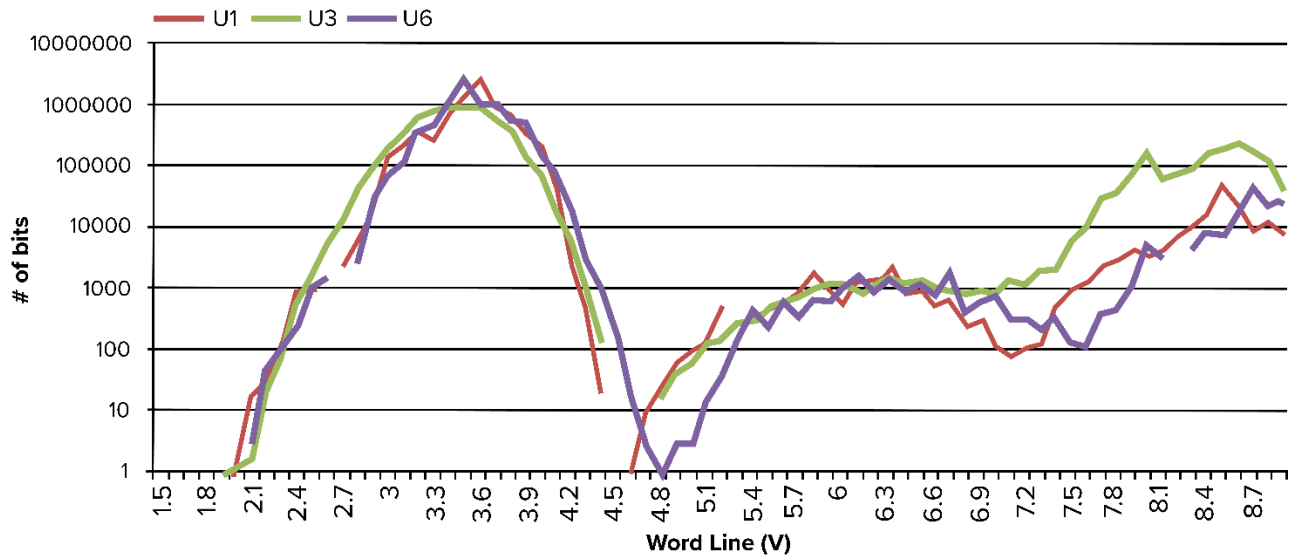
Figure 2: This image shows poor cell margin separation data for flash memory where there has been significant noise present on the SPI lines

The data in Figure 2 shows the effects of excessive noise on the serial interface. Figure 3 below shows a representation of what this overshoot would look like in a real application.

The result of this noise was erroneous device operation, which showed up as errors in the serial flash memory stored values. Initially, the true impact of the errors was missed, as polling the STATUS register on a less frequent basis reported fewer errors, leading the designer to make incorrect assumptions on the root cause of the failure.

Although this fault appeared as a memory failure, the root cause was not with the Flash devices. This was discovered by Dialog engineers by probing the SPI signals and identifying possible effects of noise in the system and disruption to the stored memory contents. This was verified by taking a 'faulty' device where the memory cell margin analysis was shown in Figure 2 above, and then erasing and re-programming the same device in a clean environment and showing that the cell margins returned to a normal profile map as shown in Figure 1 above.

While the noise could be partly attributed to an impedance mismatch present on the PCB track between the MCU and Flash memory, it wasn't the full story. The source of the noise was actually proven to be due to the high MCU default I/O Drive levels, which defaults to a highest drive level at power-up. The excessive drive was enough to cause overshoot and under-shoot on the SPI lines, which in some cases can be misinterpreted as signal transitions, leading to read or write errors. However, in this instance it was found that the overshoot held sufficient energy to disrupt the Flash charge pump, which was in turn causing programming and erase errors.

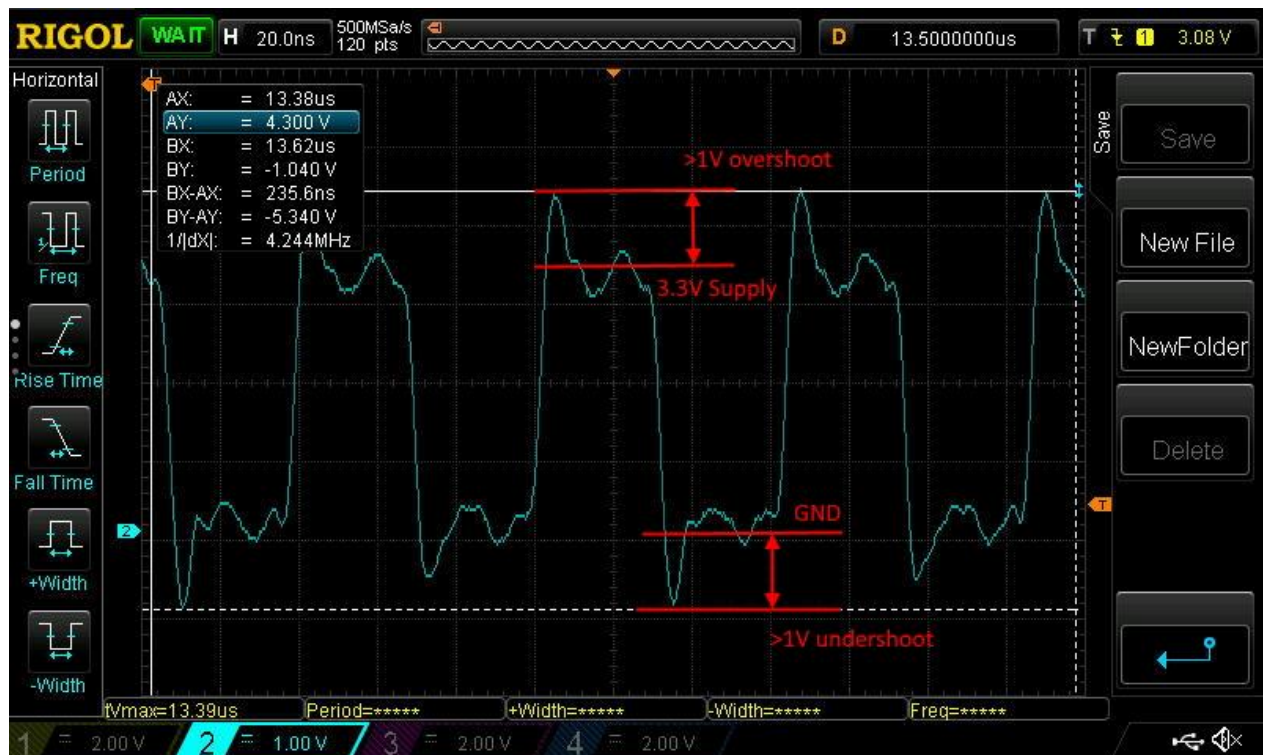
Figure 3: This trace image clearly shows the overshoot and undershoot present on the SPI lines were resulting in a peak-to-peak voltage of 5.65V, which exceeds the absolute maximum value documented in the Flash memory specification.

In the customer’s design, the microcontroller being used provided a configurable drive current for its I/O, which defaults to HIGH at start-up. As the application code did not modify this level during initialization it remained high in normal operation. The impact of this may not be apparent for other devices on the SPI bus, as digital interfaces are typically designed to be robust. The nature of flash memory, the need to operate at much higher frequencies, and in particular, the operation of the charge pump, made the memory susceptible to large overshoot/undershoot. This led to erroneous operation that was initially misinterpreted as a fault in the flash memory device. Reducing the drive current, through firmware, reduced the overshoot and undershoot to effectively zero (Figure 4), and in turn resulted in error-free operation of the flash memory.

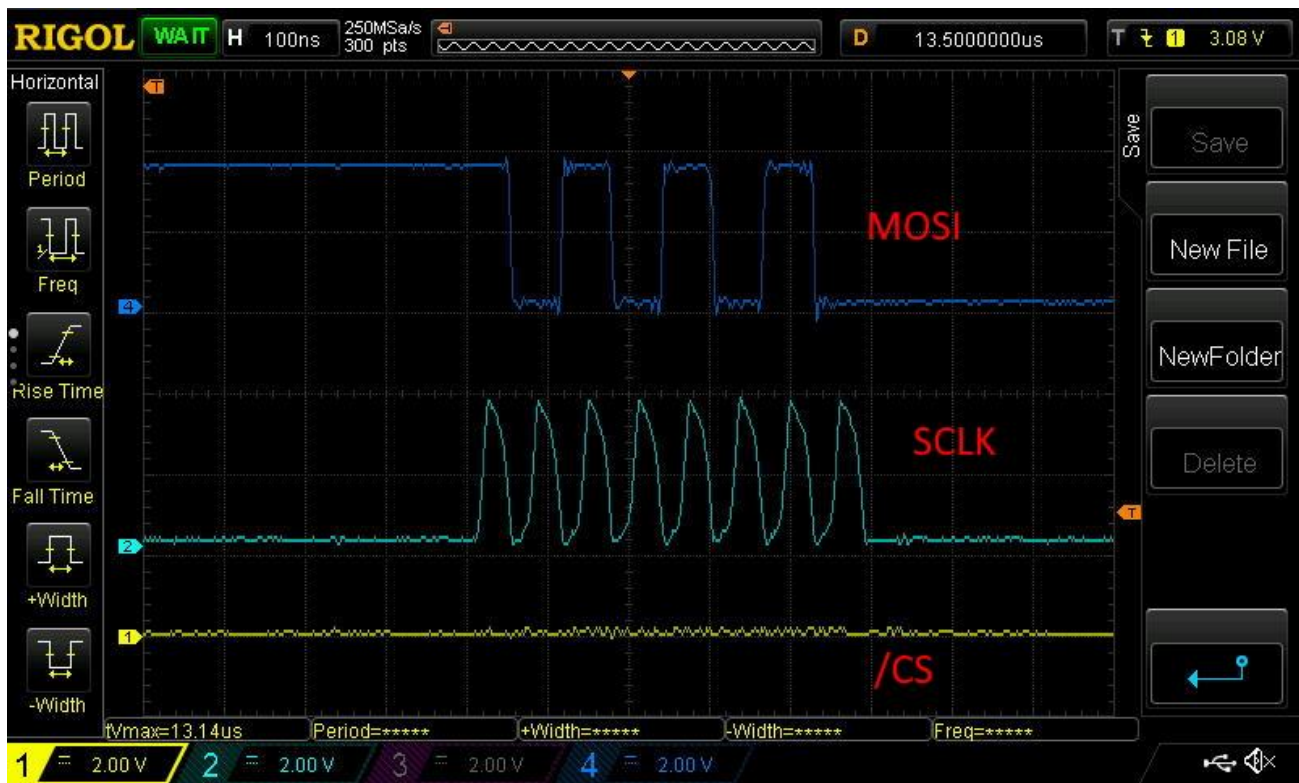
Figure 4: With no overshoot apparent, the serial Flash memory’s charge pump was able to operate correctly and provide reliable functionality

The nature of the fault showed that the flash device was making every effort to compensate for the effect of the error, which was the excessive system noise on the SPI interface. Perhaps the most significant point here is that the cause was actually a design feature of the MCU used, which defaulted to an operating mode that, in most situations, would be entirely acceptable. The combination of a high drive output and imperfect PCB inductance created a condition that resulted in intermittent failure. Reducing the drive output on the MCU, through a simple firmware change, solved the issue.
