Errata SLG47105 CE-GP-003

This document contains the known errata for SLG47105 and the recommended workarounds.

Revision 1.2

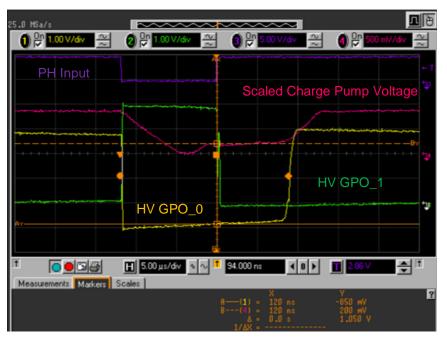
In the Fast Decay mode, the negative voltage, created by the inductive load on the HV_GPO_HD pin, discharges the internal Charge Pump due to the parasitic p-n junction. Because of this, the Rising Edge on the High Side pin shifts. The duration of the shift depends on the Duty Cycle, the High Side input voltage (V_{DD2}), and the PWM frequency.

For example, the PWM Duty Cycle values higher than 75 % in a combination with V_{DD2} voltage lower than 3.75 V, and the Fast Decay settings applied can cause this problem, please see Figure 1 and Figure 2.

Figure 1: Shifted Rising Edge (V_{DD2} = 3.0 V, Fast Decay, PWM = 75+ %)

The best way to exclude a possibility of such a malfunction is to use the Slow Decay option for the H-Bridge instead of the Fast Decay. No evidence of improper behavior has been discovered when V_{DD2} is higher than 3.75 V and the Fast Decay settings are applied. The chip is not affected by this problem when the load is resistive, because the negative voltage will appear on a pin only when the inductive load discharges.

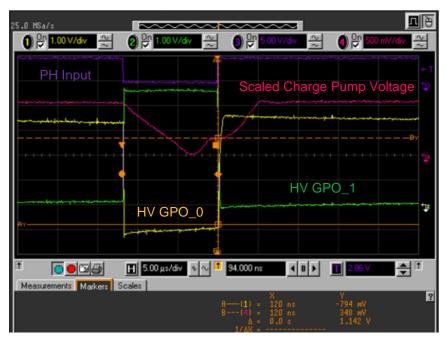
Figure 2: Discharge of the Internal Charge Pump (V_{DD2} = 3.75 V, Fast Decay, PWM = 75+ %)

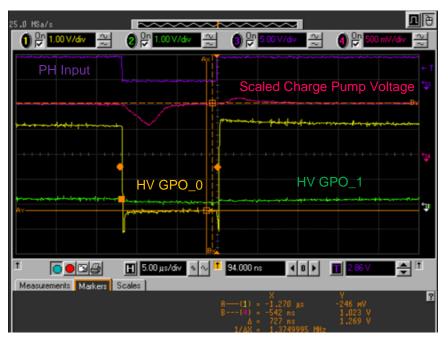
Figure 3: Rising Edge is Not Shifted (V_{DD2} = 3.75 V, Slow Decay, PWM = 75+ %)

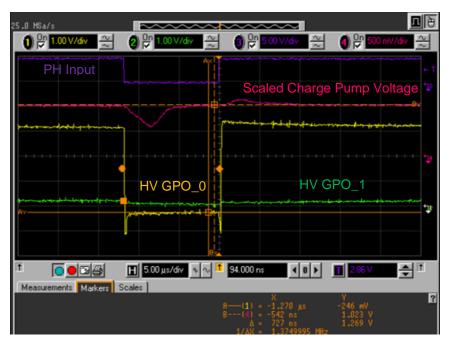
Figure 4: Low V_{DD2} Voltage Operation (V_{DD2} = 2.75 V, Slow Decay, PWM = 75+ %)

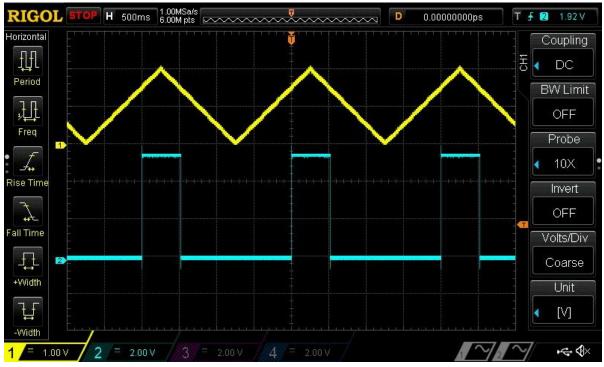
If using ACMPxH in with 32 mV or 64 mV hysteresis, ACMPxH output could be glitching when ACMPxH positive input (IN+) is close to the negative input (IN-). It can happen when V_{DD} higher 4.6 V and Vref is in a range from 1.344 V to 2.016 V for 32 mV hysteresis, and Vref is in a range from 1.376 V to 1.664 V for 64 mV hysteresis.

1. Waveform at Vref = 1504 mV, hysteresis is equal to 32 mV.

Figure 6: ACMP Output during Glitching

Use the deglitch filter connected to the ACMPxH output.

Avoid conditions described in paragraph 3.3.2.

Decrease the reference to avoid conditions described in paragraph 3.3.2 at IN- and add the IN+ gain to keep the needed threshold.

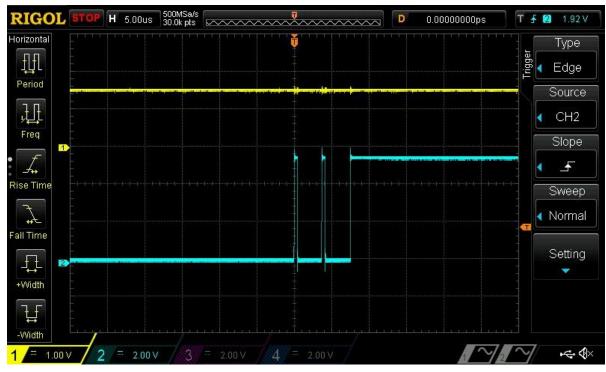
2. Waveform at Vref = 1504 mV, hysteresis is equal to 32 mV (zoomed rising edge).

Figure 7: Zoomed ACMP Output during Glitching

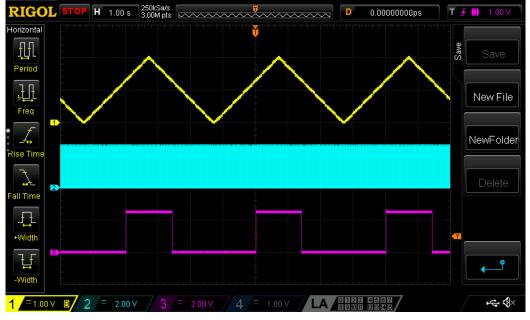
When WS Ctrl is used for controlling the power on/off of analog macrocells ACMPs for power saving, ACMPxH shows erroneous behavior for certain Vref selection. Vref transient settling error is observed for both WS Ctrl Wake time modes, Short wake time and Normal wake time (selections under CNT0 settings).

1. Waveform at Vref = 1312 mV, hysteresis is equal to 32 mV

Figure 9: ACMP0H Output during Glitching

1. If ACMP is used with WS Ctrl counter, CNT0, avoid conditions described in paragraph 3.4.2.

2. Decrease the reference to avoid conditions described in paragraph 3.4.2 at IN- and add the IN+ gain to keep the needed threshold.

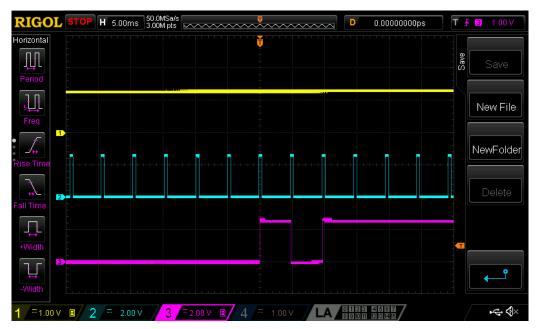
2. Waveform at Short wake time mode, Vref = 1312 mV, hysteresis is equal to 32 mV (zoomed rising edge).

Figure 10: Zoomed ACMP Output during Glitching at Short wake time mode

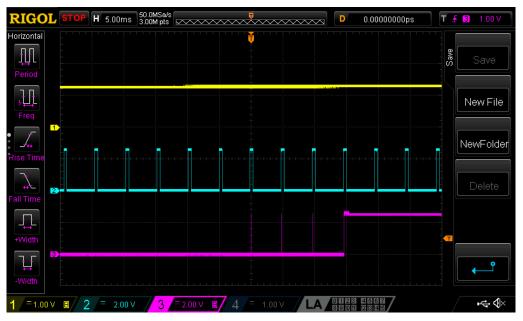
3. Waveform at Normal wake time mode, Vref = 1312 mV, hysteresis is equal to 32 mV (zoomed rising edge).

Figure 11: Zoomed ACMP Output during Glitching at Normal wake time mode
