## Engineering Change Notice (ECN)

**Design Affected:** DA14680 wearable daughter board (224-37-C)

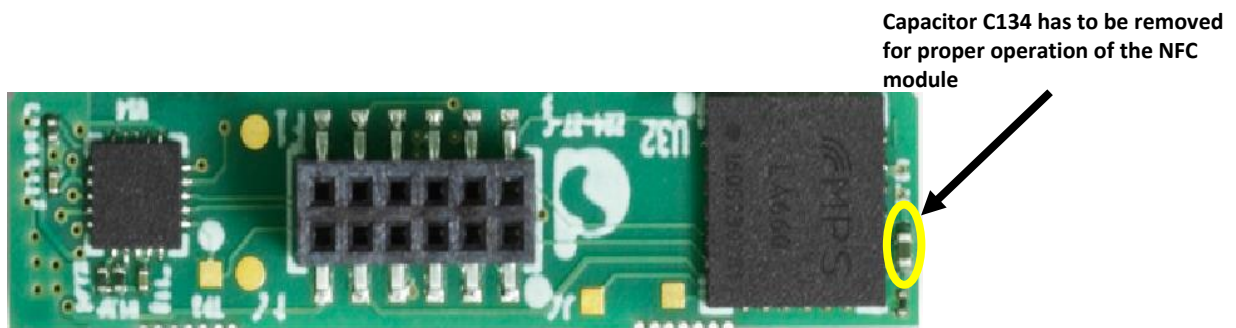
**Function affected:** NFC operation

**Symptom:** NFC is failing to connect even in contactless mode

De-coupling capacitor C134 (1uF) connected at the power supply pin of the NFC module LA66C300 has to be de-assembled for the NFC contactless mode to operate as expected:
