Known Software Issue List

ER-B-001

This document contains the collection of known issues in the current SDK 1.0.12 including a description and possible work-around(s) and/or solution(s).

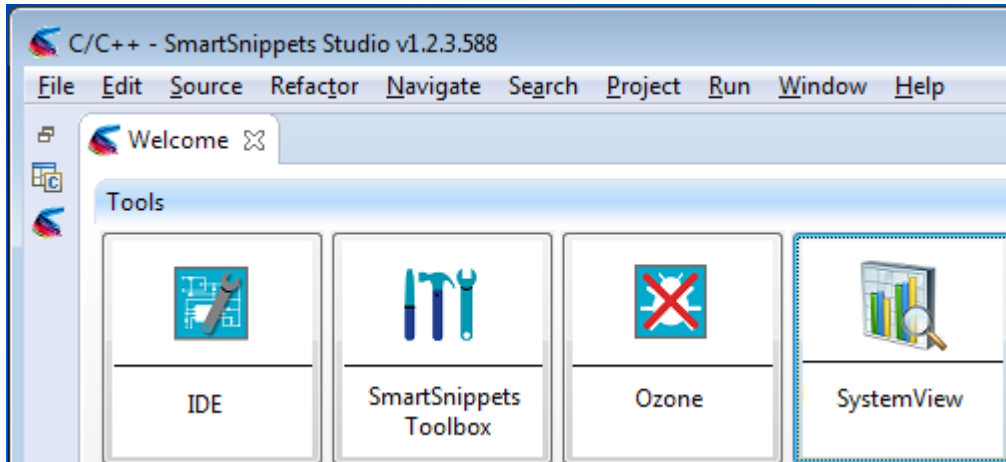
Figure 1

During installation of the SmartSnippets Studio the installer asks to download and install Segger's Systemview software (if not already present). When starting the Systemviewer from the SmartSnippets Studio home page, it will not start.

In certain cases 2 *.dll files are missing: msvcp100.dll and mscrt100.dll. These 2 files are present in Segger's Ozone software directory and can be copied either to the Systemview directory or Windows System32 directory.

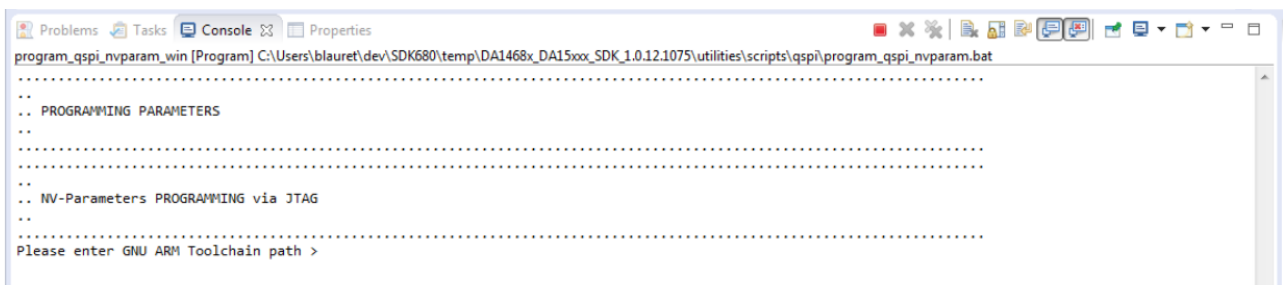
On a brand new installation of a new SDK, it appears that trying to program the nvparams, the tools fail to find the arm gcc and request for the path:

Restart Eclipse and the path will be found as expected.
