SLG46140

ISSUE 1: ACMP Output is Inaccurate when using External Vref at High VDD and Temperature Functional Block Affected: ACMP

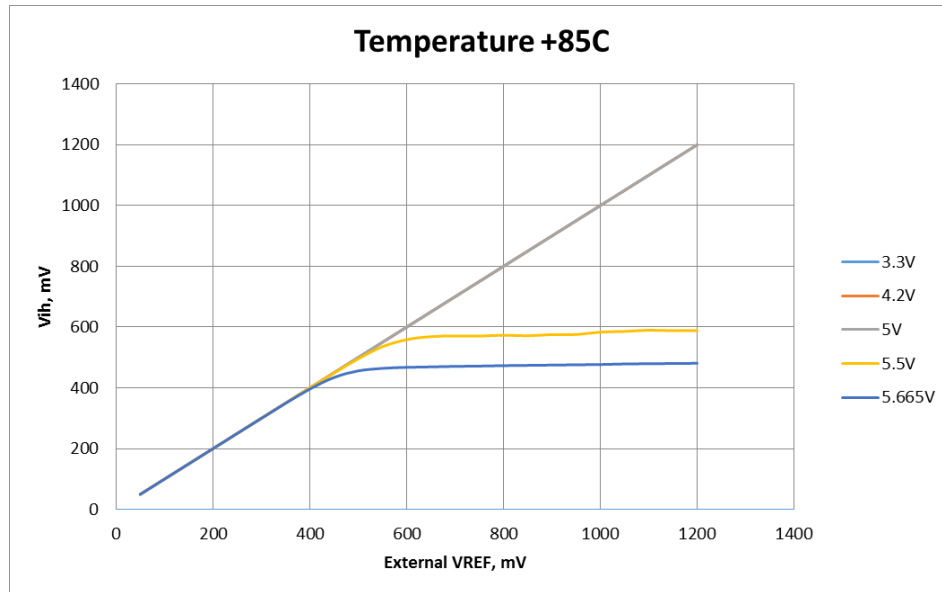
When using external Vref source, the ACMP comparison may happen at wrong threshold if the external Vref voltage is higher than a particular value (please see figure below) at high VDD values (> 5V) and high temperature.

Avoid using ACMPs in such conditions.

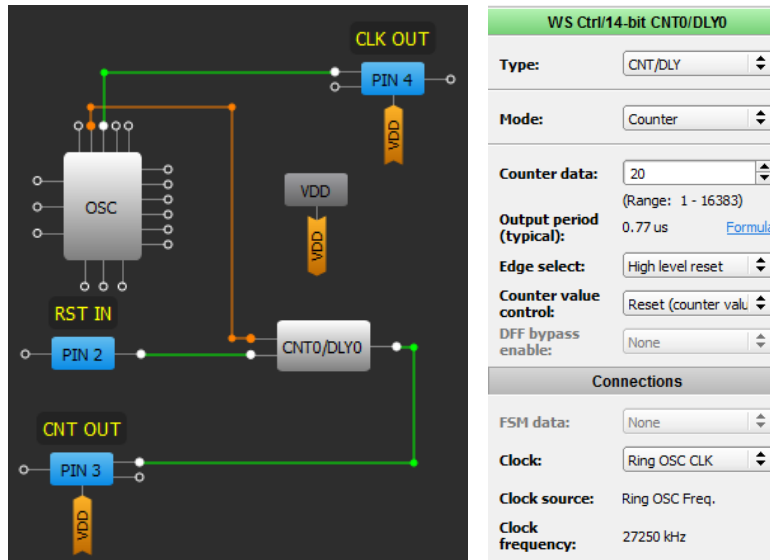
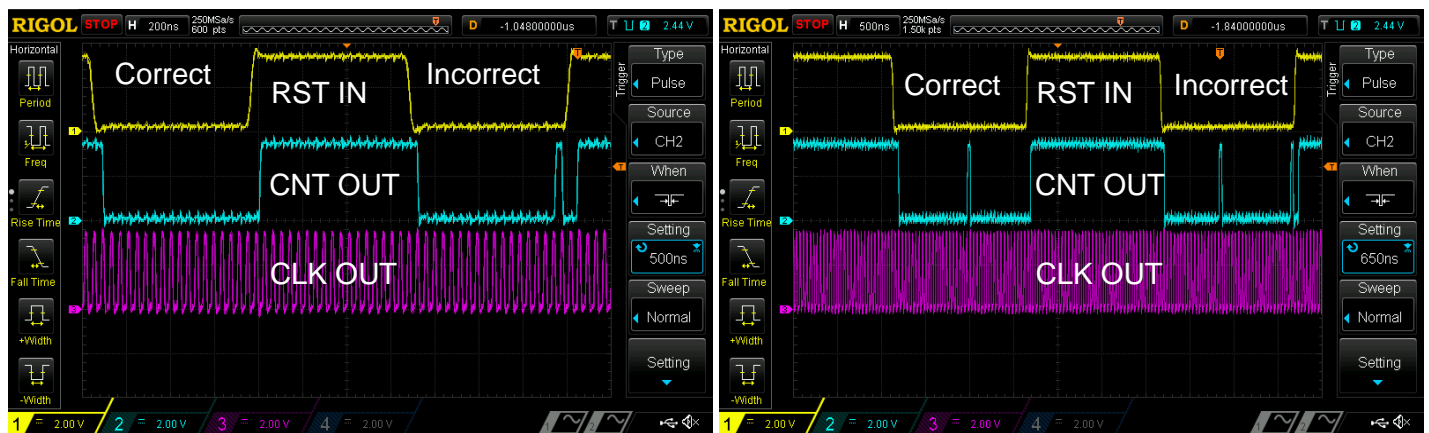
ISSUE 2: Incorrect Counter Operation after the Reset Functional Block Affected: Counter

If the Counter Reset occurs at a time very close to a rising edge of the clock signal during clock signal generation (for example OSC operation), there is a possibility that the Counter Data of the Counter is reset incorrectly and the counter end signal (HIGH pulse) may appear faster than expected. This phenomena appears more frequently the higher the clock frequency is.

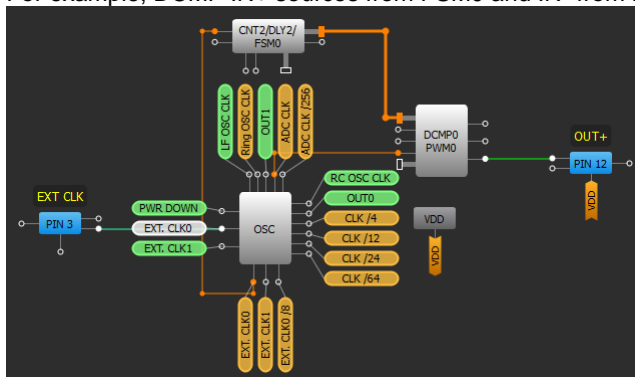
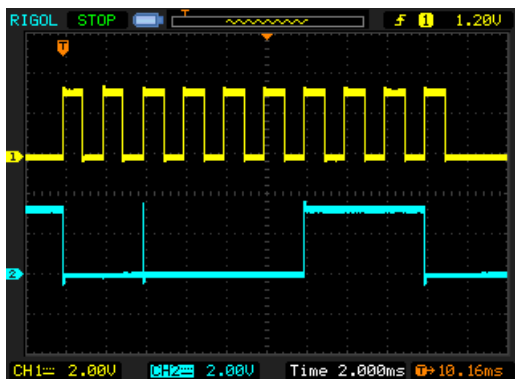
ISSUE 3: DCMP OUT+ Output Glitch
Functional Block Affected: DCMPs

DCMP's OUT+ output may have a glitch when the input data is changed. This issue appears more frequently the higher the DCMP clock is.

For example, DCMP IN+ sources from FSM0 and IN- from Register0. DCMP is clocked from the Ring OSC.

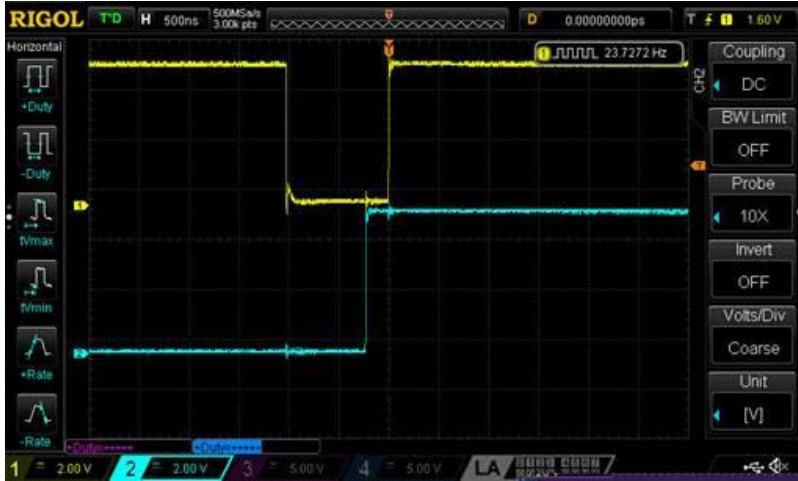
ISSUE 6: ACMP Output Glitch due to Ring OSC Operation Functional Blocks Affected: W/S Control, ACMP

The output of the ACMP incorrectly goes low even when IN+ is greater than IN- if the RING OSC is active when the WS signal rises

Channel 1 – ACMP out

Channel 2 – WS_OUT

- Avoid using the RING OSC with the WS Controller, or add a filtering block on the ACMP output to filter out the glitch.

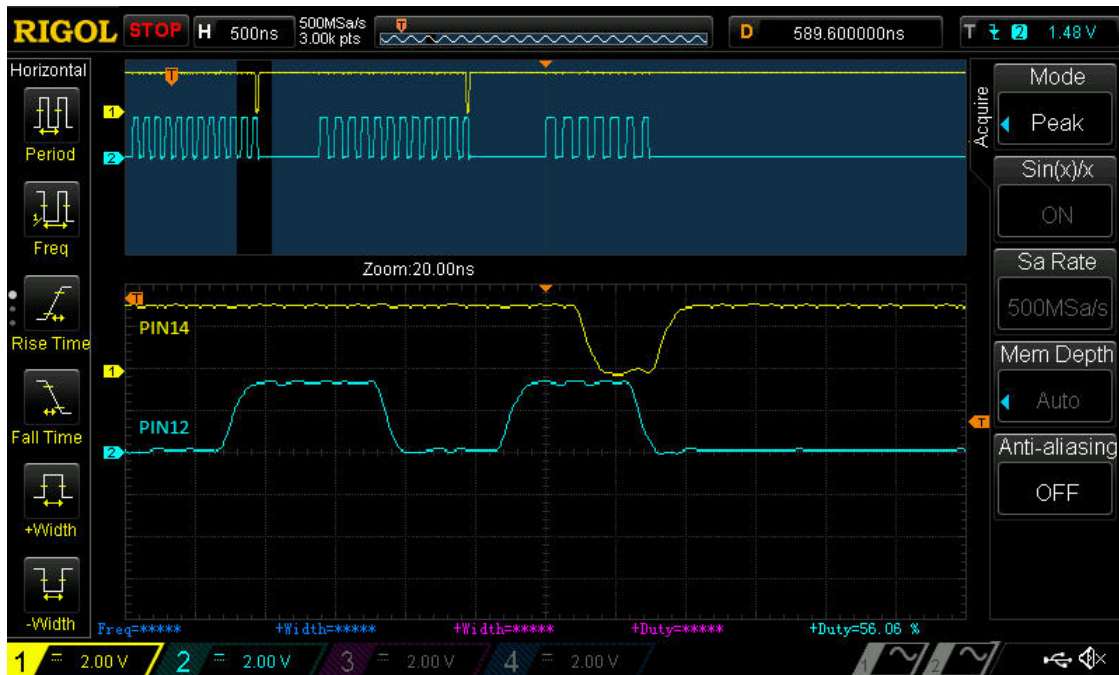
The configuration shown above generates a periodical signal with a frequency defined by the Delay cell and started by a high signal on PIN2. The issue becomes apparent in a longer settling time when the scheme generates short pulses (Delay is configured as a rising edge delay only). See waveform below.

Channel 1 – 2-bit LUT0 output; Channel 2 – Ring OSC output

Such behavior will lead to substantial error in period calculations if the delay time is relatively small.

- Set Ring OSC power mode to “Force Power On”
- or, Set Turn on by register option in BG (Band Gap) block as “Enable”

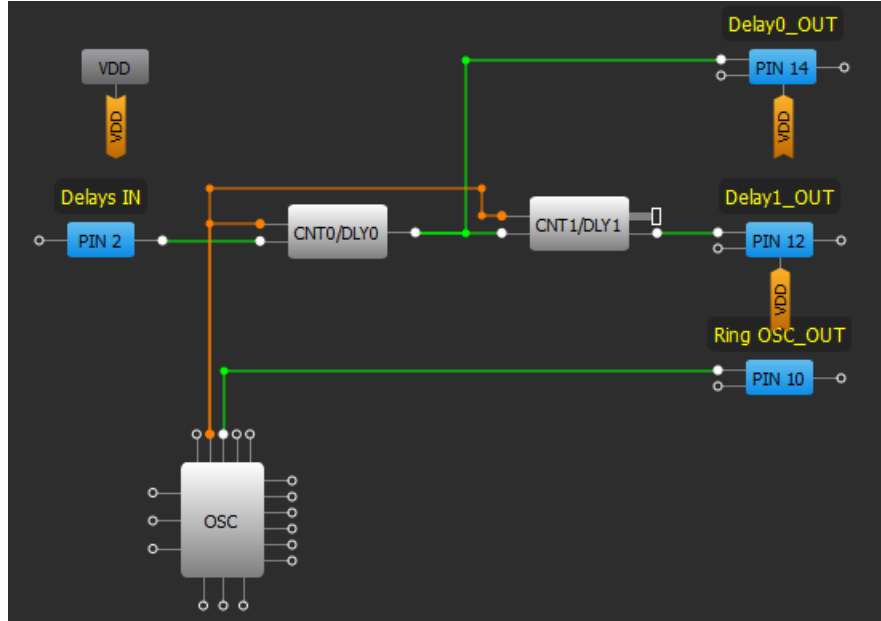
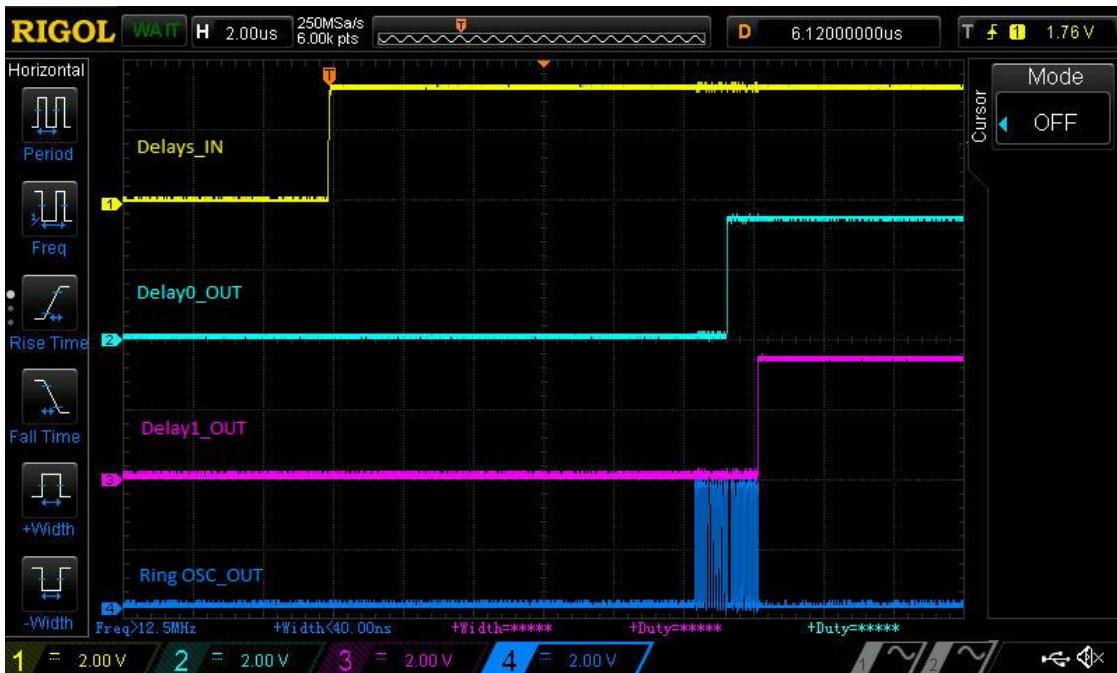
A similar situation occur while using two connected delays (all edge detect types except for a pair “Rising edge DLY – Falling edge DLY”).

In the following example, Delay0 and Delay1 are configured in the same way. However, Delay0 time is 11.4us instead of expected 0.4us (Delay0 time).
