SLG46582

ISSUE 1: Long 2 MHz OSC Settling Time
Functional Block Affected: OSC, Counter, Delay

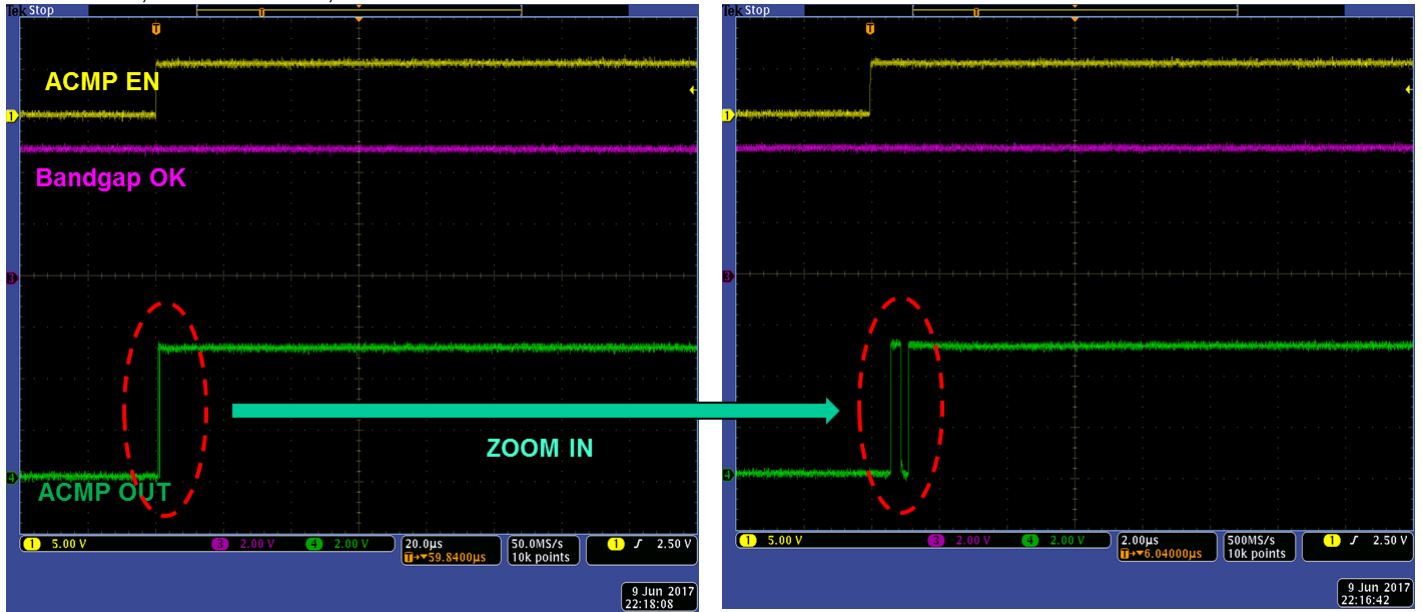
VDD = 5.0 V, ACMP IN+ > IN-, One of LDOs enabled

Because BG_OK is already released by LDO, there is no gating signal. Depending on the ACMP VREF condition & the positive input value, it is possible for the ACMP to have a glitch. Subsequently, the other ACMP will not have an issue unless the customer repeats LDO enable first and ACMP later during power stable.

- Use both edge delay on the output to filter out the glitch.

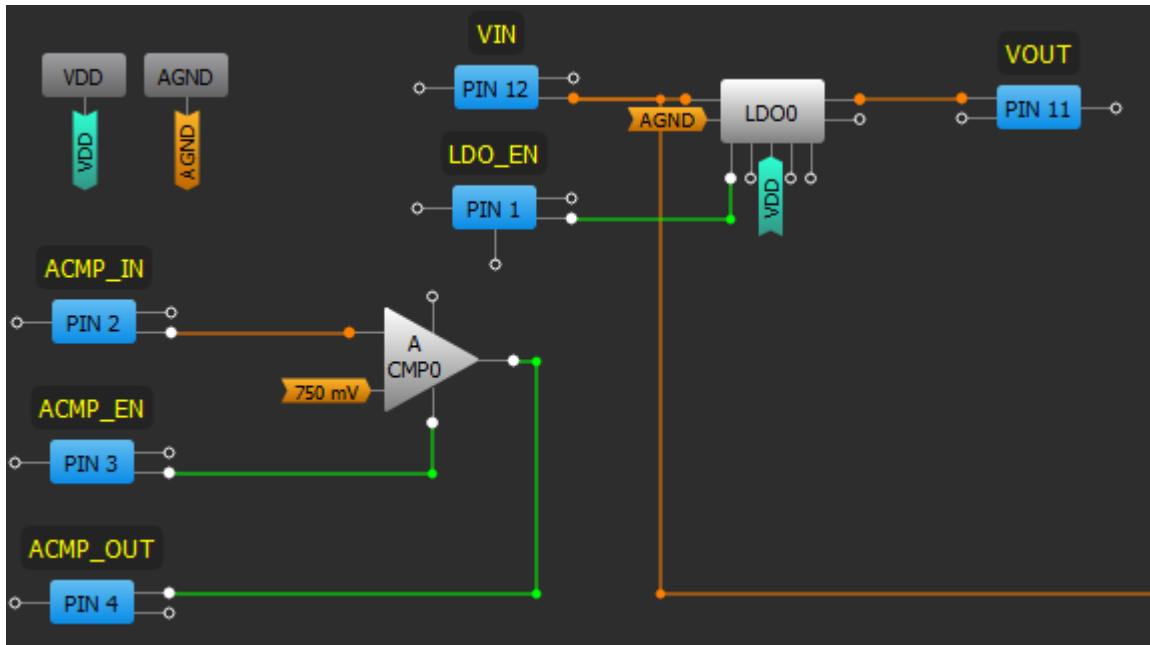
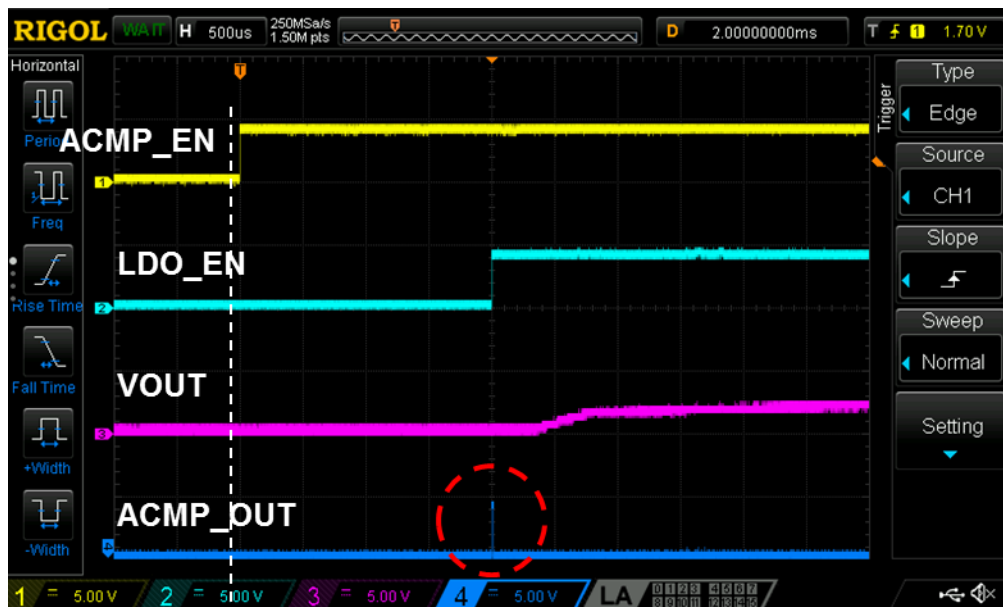
If an LDO's Low Power Mode is selected (for example tied to VDD) a glitch may appear on the ACMP's output after the first LDO is enabled. When the first LDO is turned on, the Low Power Mode switch causes a drop in the internal bandgap voltage that is used to derive the ACMP reference voltages.

- Use both edge delay on the output to filter out the glitch.
- Use some logic to avoid turning on Low Power Mode before enabling LDO and powering up the ACMP. Example is shown below.

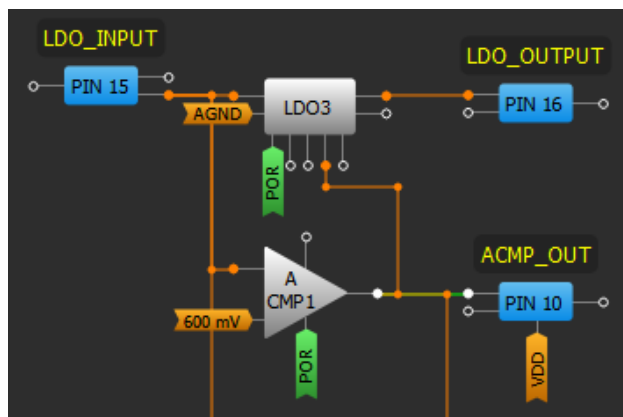
If an LDO's VIN pin (LDO_INPUT) has an internal connection (depicted with an orange wire) to the ACMP's IN+ port, the ACMP's output may give an erroneous result with respect to the LDO's input voltage. The switch between the LDO's VIN pin and the ACMP's IN+ port is implemented using an NMOS-only based transmission gate with its gate controlled by logic supplied from VDD. As a result, this switch is unable to pass LDO input voltages that are close to VDD. This can result in the ACMP's IN+ port seeing a lower voltage than the actual voltage present at LDO_INPUT. This lower input voltage may cause the output of the ACMP to behave unexpectedly.

If the LDO's UVLO feature is enabled, the ACMP's output will cause unexpected LDO behavior that results from the previously described transmission gate voltage drop.

- If the GreenPAK's VDD is always powered up before the LDO's VIN input, you can externally short the LDO's VIN to another dedicated analog input pin for the desired ACMP.

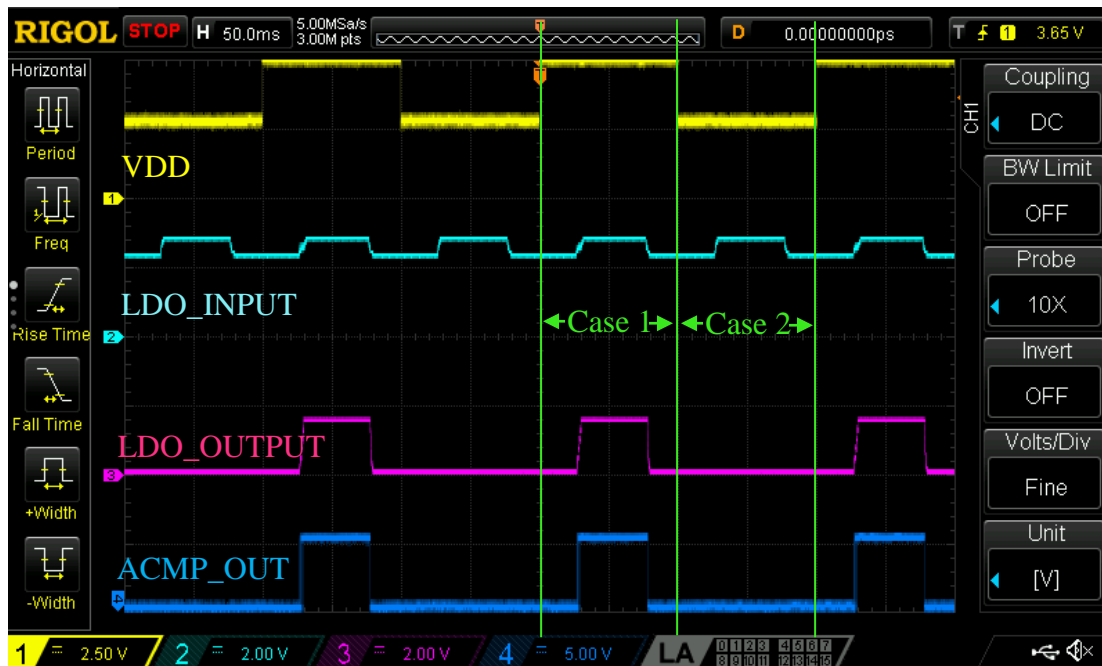
Case 1: Proper Behavior at VDD = 5V;

With a 5V VDD, the NMOS transmission gate passes the 2.25 and 2.75V LDO_INPUT pin voltages to the ACMP's IN+ port. When the input voltage exceeds the 2.4V IN- threshold of the ACMP, the LDO is enabled.

Case 2: Erroneous Behavior at VDD = 2.75V;

When the VDD is reduced to 2.75V, the NMOS transmission gate is unable to pass LDO_INPUT's full magnitude to the ACMP's IN+ port. Since the IN+ port of the ACMP doesn't exceed the 2.4V IN- threshold, the ACMP's output stays low and keeps the LDO disabled.

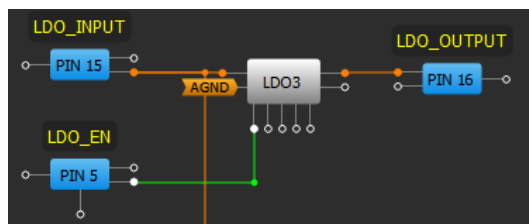
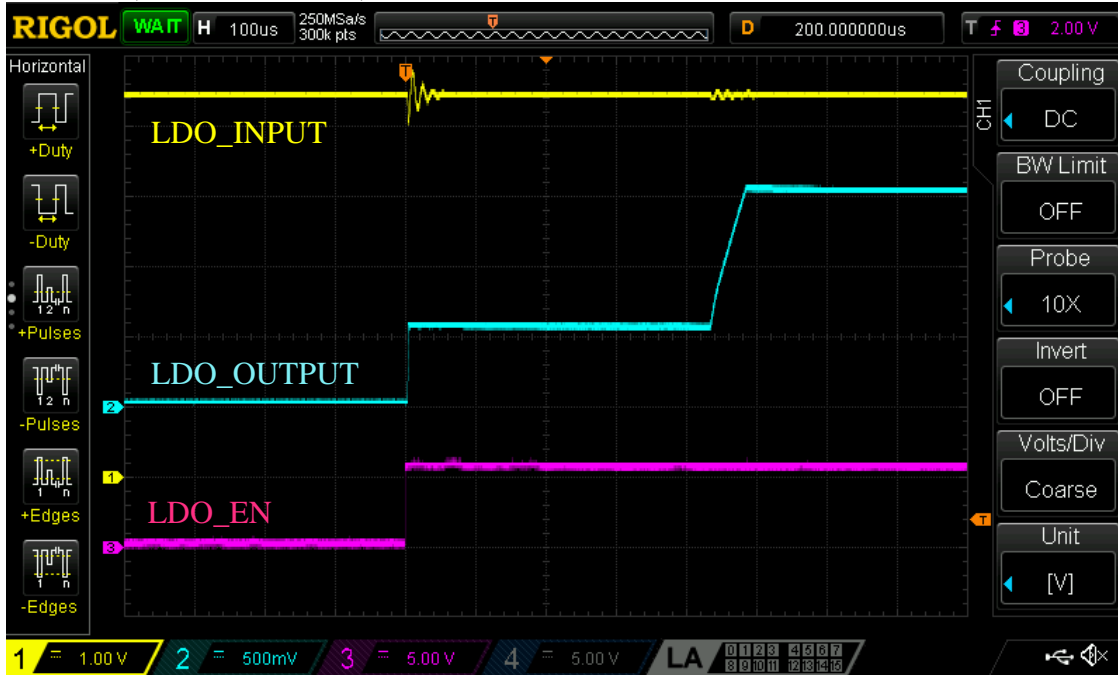
When a GreenPAK's first LDO is enabled, the LDO's VOUT will step to a non-zero voltage during its 500 μ s wait time. The magnitude of this step is directly proportional to the LDO's VIN and the GreenPAK's VDD. With a large LDO input voltage and VDD, this step can exceed 500mV.

VDD = 5.5V, LDO_INPUT = 5.5V, All other LDOs Disabled

- If your GreenPAK design has an unused LDO, you can reduce the magnitude of this voltage step by keeping an unused LDO enabled in high power mode.

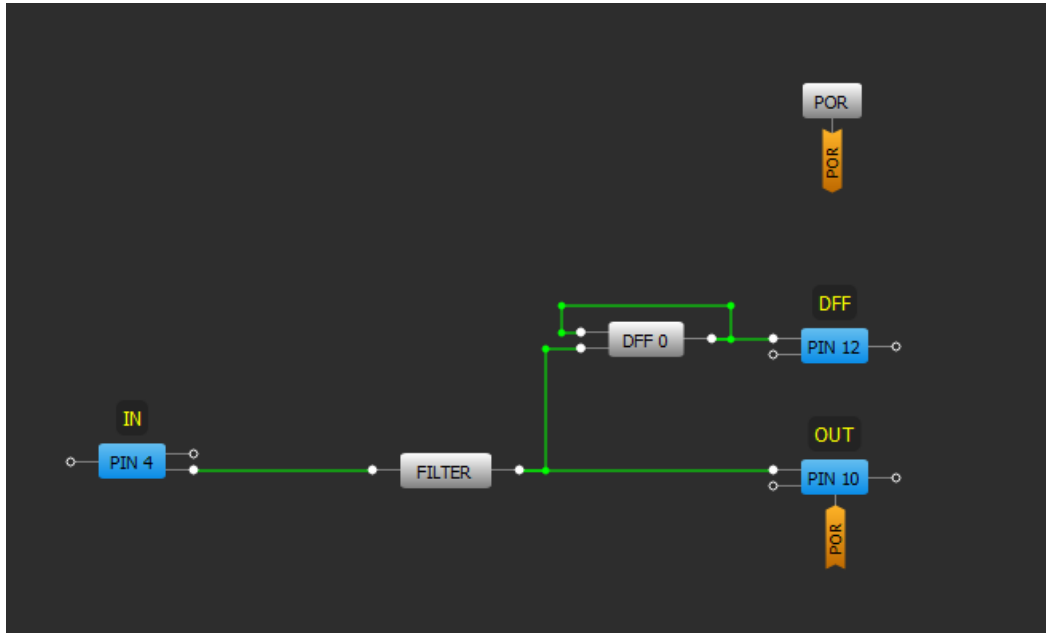
If the FILTER cell's input signal contains multiple consecutive pulses within short time intervals, the FILTER cell may not filter the input pulses as expected. The errant behavior applies only to repeated input pulses and depends on both their frequency and duty cycle.

Channel 1 (yellow/top line) – PIN#4 (IN)
 Channel 2 (light blue/2nd line) – PIN#10 (OUT)
 Channel 3 (magenta /3rd line) – PIN#12 (DFF)

Currently, there is no workaround for this issue. The FILTER block correctly filters isolated glitches, but it shouldn't be used to filter repetitive, high frequency input signals.

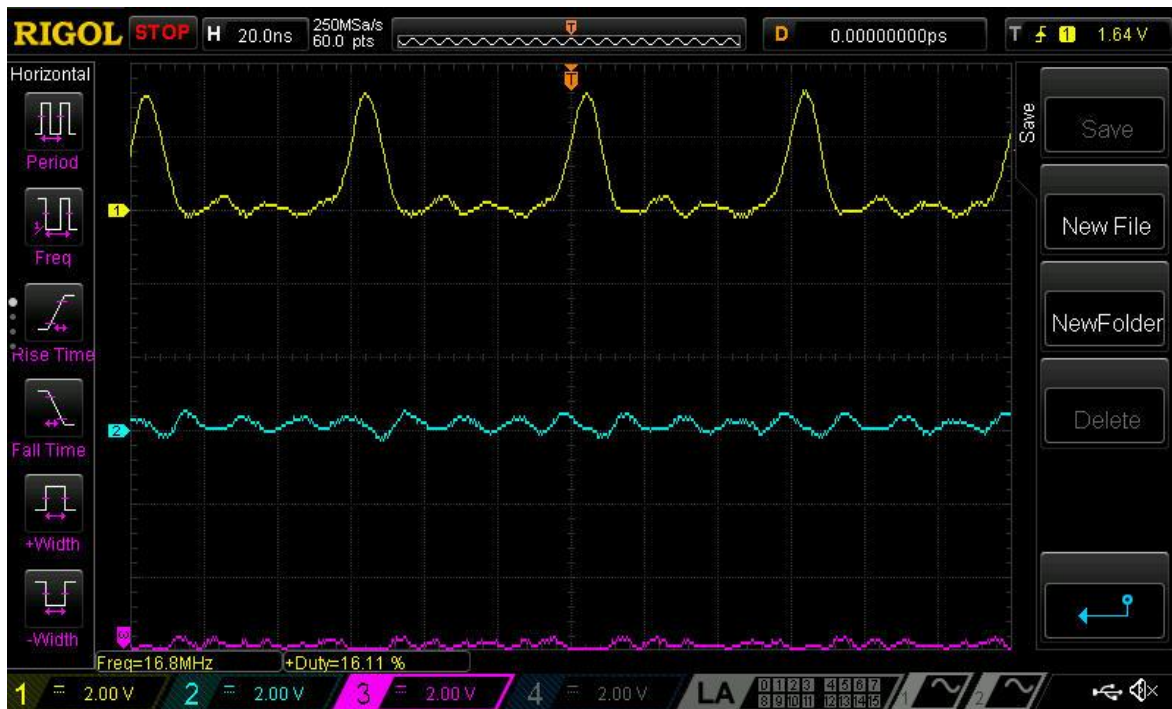
1. Period is 60ns. Pulse width is 10ns DC=16.7% (Correct functionality)

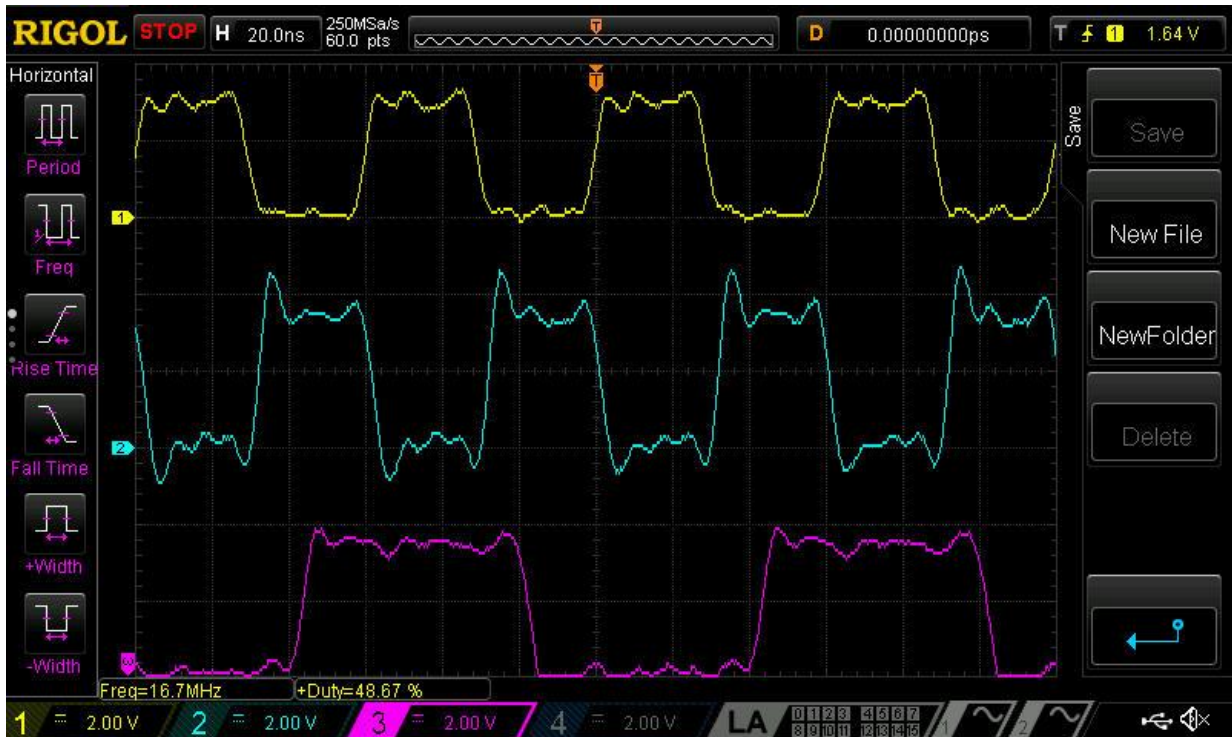
3. Period is 60ns. Pulse width is 30ns DC=50% (Incorrect functionality)

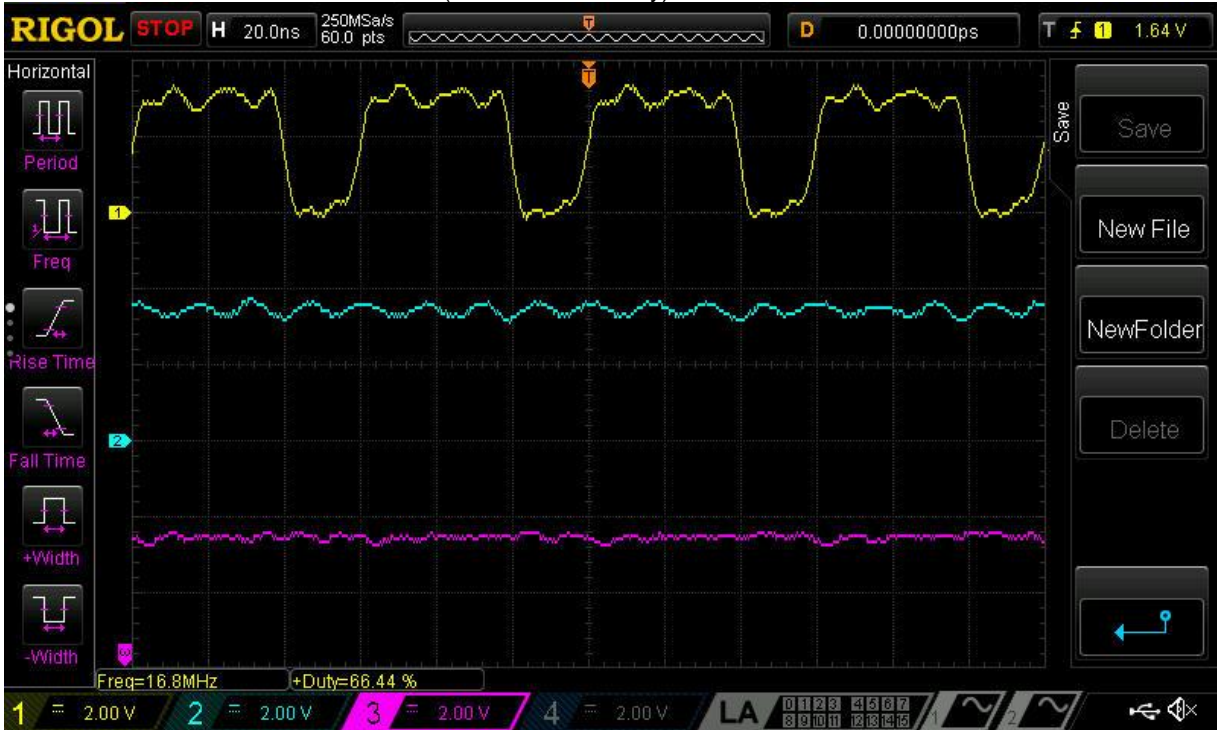
4. Period is 60ns. Pulse width is 40ns DC=66.67% (Correct functionality)

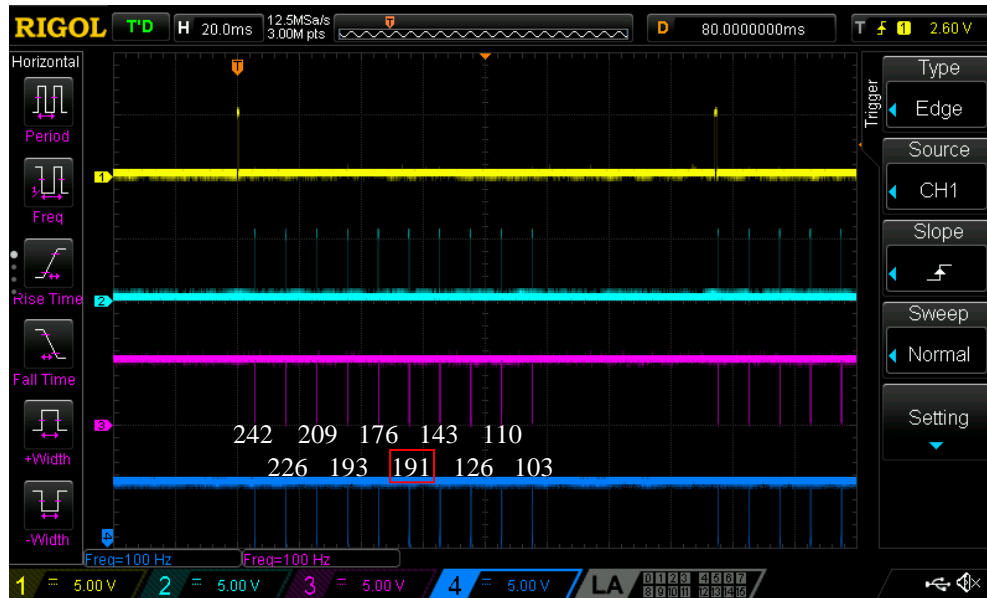
Asynchronous interaction between the CNT/DLY clock input and the I²C latch signal (generated by an I²C read command of the CNT/DLY block's count value) can result in an incorrect I²C data read. The CNT/DLY block will count accurately, but the count value transferred into the block's I²C read register might be loaded incompletely if the I²C latch signal and the clock input occur at about the same time.

The example data capture below shows ten periodic I²C reads of CNT2/DLY2 configured to count down at about 16 clocks per read. The sixth read sample erroneously shows a value greater than that of the fifth. The seventh sample reads as if the previous I²C error never occurred - the difference from the fifth sample (176) to the seventh (143) is 33 clocks or 16 clocks + 17 clocks as expected.

- Channel 1 (yellow/top line) – PIN#2 (CNT2/DLY2 Out)
- Channel 2 (light blue/2nd line) – PIN#1 (I2C Read Triggers)
- Channel 3 (magenta /3rd line) – PIN#8 (I2C SCL)
- Channel 3 (dark blue /4th line) – PIN#9 (I2C SDA)

If the possibility of incorrect I²C data reads can't be accommodated for by external software checks, one can guarantee proper operation by stopping the CNT/DLY block's clock during I²C reads through one of the following methods: by disabling the oscillator block, by reconfiguring the CNT/DLY block's clock source, or by gating an external clock using a LUT (Look-up Table) in the signal matrix. After disabling the CNT/DLY block's clock, the count registers can be read without error. Please note that this workaround will add the I²C read and processing time to the counter's overall clock period.

The best workaround depends on the resource constraints of the application. If the oscillator block doesn't clock other logic elements within the design, a matrix output can be used to manually power down the oscillators for the I²C read. When the CNT/DLY block's clock source is routed internally from the oscillator block, I²C commands can temporarily reconfigure the CNT/DLY block's clock source registers to select "Ext. CLK. (From Matrix)." This action will disable the clock by connecting it to ground. If the CNT/DLY block is clocked from the signal matrix, a LUT can be used to gate the clock during an I²C read.
