SLG46585

ISSUE 1: FILTER Cell does not Filter Out Repetitive Glitches

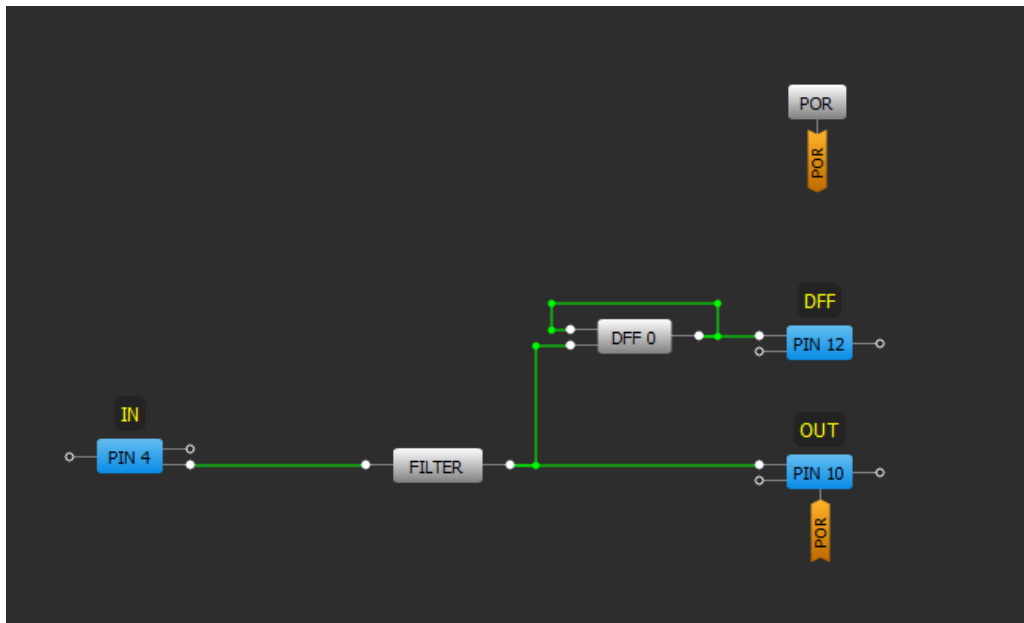
If the FILTER cell's input signal contains multiple consecutive pulses within short time intervals, the FILTER cell may not filter the input pulses as expected. The errant behavior applies only to repeated input pulses and depends on both their frequency and duty cycle.

- Channel 1 (yellow/top line) – PIN#4 (IN)
- Channel 2 (light blue/2nd line) – PIN#10 (OUT)
- Channel 3 (magenta /3rd line) – PIN#12 (DFF)

Currently, there is no workaround for this issue. The FILTER block correctly filters isolated glitches, but it shouldn't be used to filter repetitive, high frequency input signals.

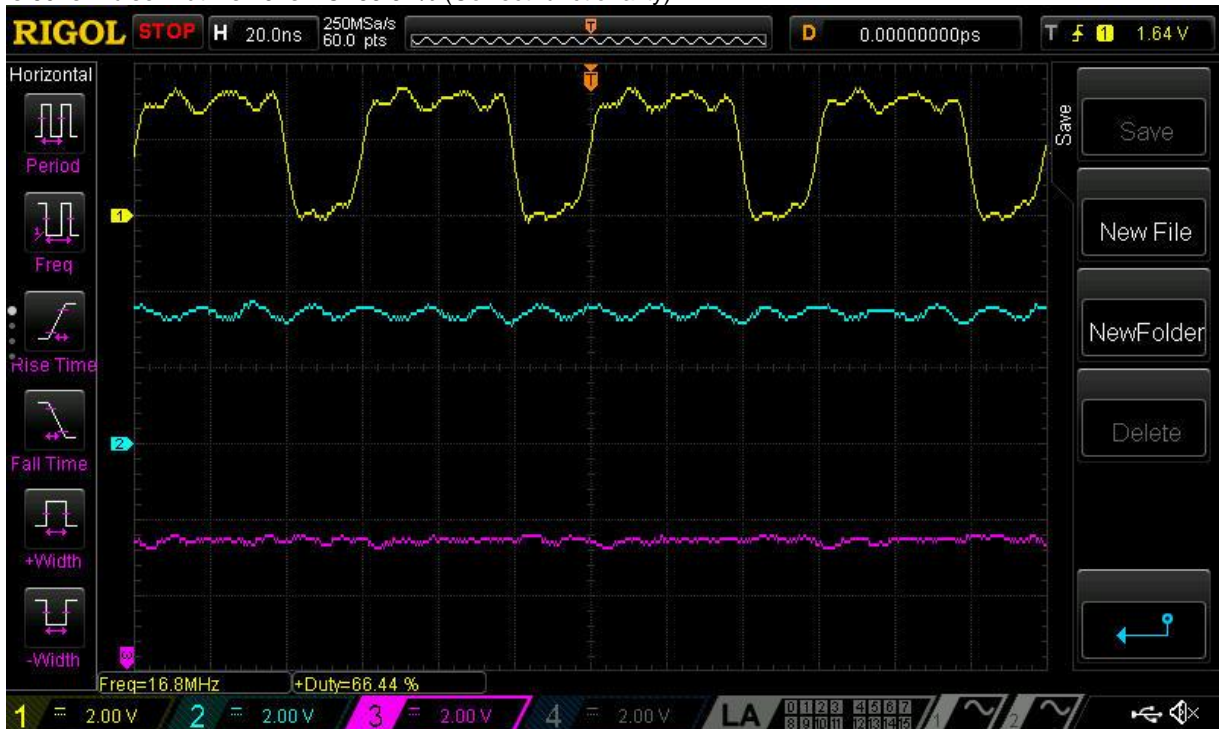
4. Period is 60ns. Pulse width is 40ns DC=66.67% (Correct functionality)

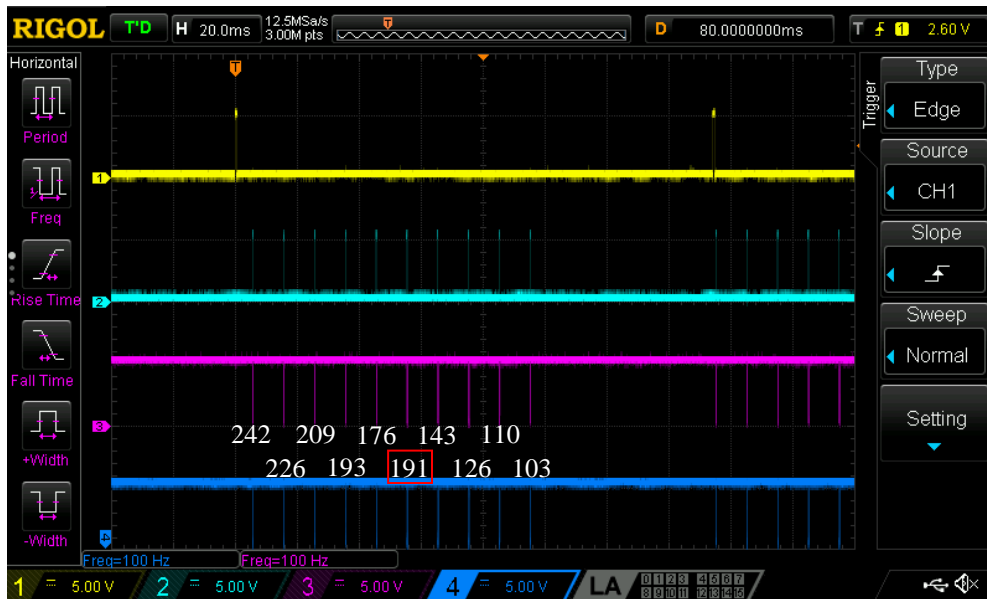
Asynchronous interaction between the CNT/DLY clock input and the I²C latch signal (generated by an I²C read command of the CNT/DLY block's count value) can result in an incorrect I²C data read. The CNT/DLY block will count accurately, but the count value transferred into the block's I²C read register might be loaded incompletely if the I²C latch signal and the clock input occur at about the same time.

The example data capture below shows ten periodic I²C reads of CNT2/DLY2 configured to count down at about 16 clocks per read. The sixth read sample erroneously shows a value greater than that of the fifth. The seventh sample reads as if the previous I²C error never occurred - the difference from the fifth sample (176) to the seventh (143) is 33 clocks or 16 clocks + 17 clocks as expected.

- Channel 1 (yellow/top line) – PIN#2 (CNT2/DLY2 Out)
- Channel 2 (light blue/2nd line) – PIN#1 (I²C Read Triggers)
- Channel 3 (magenta /3rd line) – PIN#8 (I²C SCL)
- Channel 3 (dark blue /4th line) – PIN#9 (I²C SDA)

If the possibility of incorrect I²C data reads can't be accommodated for by external software checks, one can guarantee proper operation by stopping the CNT/DLY block's clock during I²C reads through one of the following methods: by disabling the oscillator block, by reconfiguring the CNT/DLY block's clock source, or by gating an external clock using a LUT (Look-up Table) in the signal matrix. After disabling the CNT/DLY block's clock, the count registers can be read without error. Please note that this workaround will add the I²C read and processing time to the counter's overall clock period.

The best workaround depends on the resource constraints of the application. If the oscillator block doesn't clock other logic elements within the design, a matrix output can be used to manually power down the oscillators for the I²C read. When the CNT/DLY block's clock source is routed internally from the oscillator block, I²C commands can temporarily reconfigure the CNT/DLY block's clock source registers to select "Ext. CLK. (From Matrix)." This action will disable the clock by connecting it to ground. If the CNT/DLY block is clocked from the signal matrix, a LUT can be used to gate the clock during an I²C read.
