ISSUE 1: Long Settling Time for Ring OSC Functional Blocks Affected: Ring OSC, Delay, Counter

SLG46621

Revision 0.18

2-Aug-2019

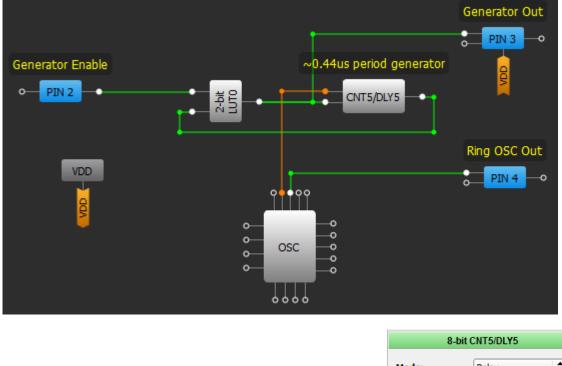
The Ring OSC has a longer settling time when configured as Auto Power On in the designs that have a very short Ring OSC disable time. An example of this issue is shown in the following configuration:

The configuration shown above generates a periodical signal with a frequency defined by the Delay cell and started by a high signal on PIN2. The issue becomes apparent in a longer settling time when the scheme generates short pulses (Delay is configured as a rising edge delay only). See waveform below.

- Set Ring OSC power mode to "Force Power On"
- or, Set Turn on by register option in BG (Band Gap) block as "Enable"

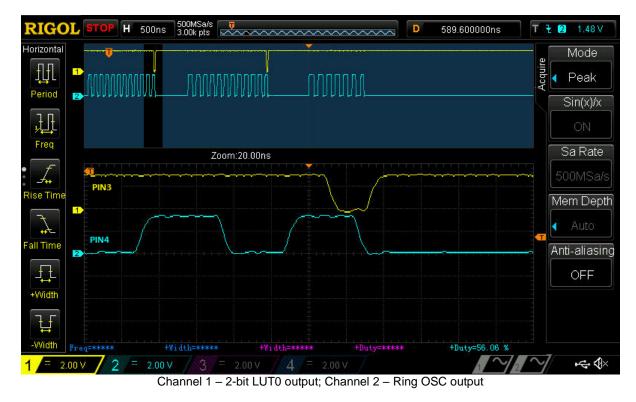
Such behavior will lead to substantial error in period calculations if the delay time is relatively small.

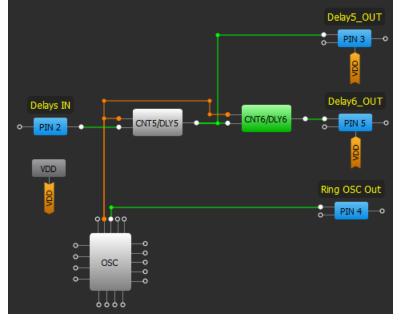
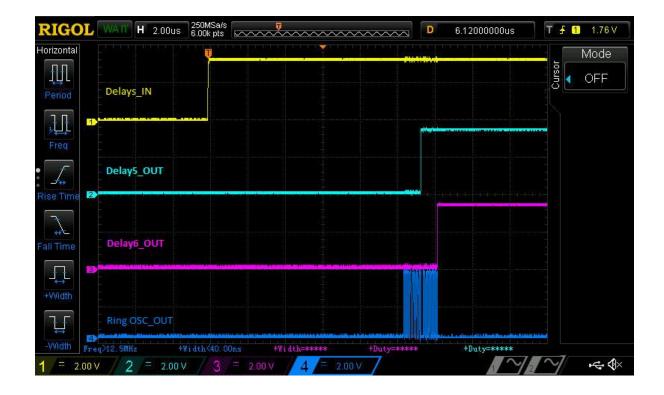
A similar situation can occur when using two connected delays (all edge detect types except when pairing "Rising edge DLY – Falling edge DLY").

In the following example, Delay5 and Delay6 are configured in the same way. However, Delay5 time is 11.4us instead of expected 0.4us (Delay5 time).

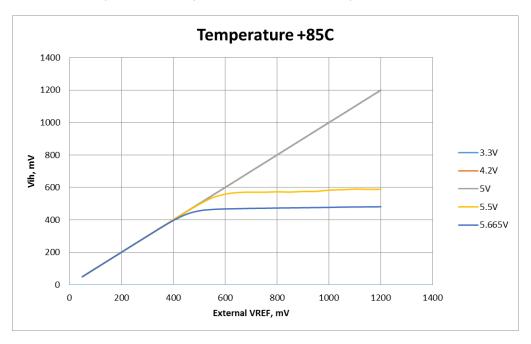
When using an external Vref source, the ACMP comparison may happen at the wrong threshold if the external Vref voltage is higher than a particular value (please see figure below) at high VDD values (> 5V) and high temperature.

• Avoid using ACMPs in such conditions.

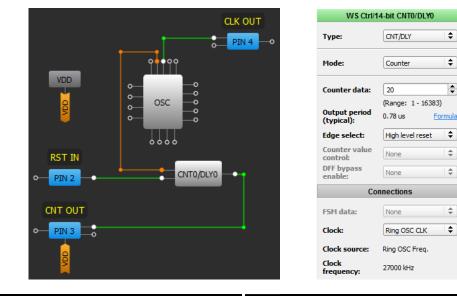
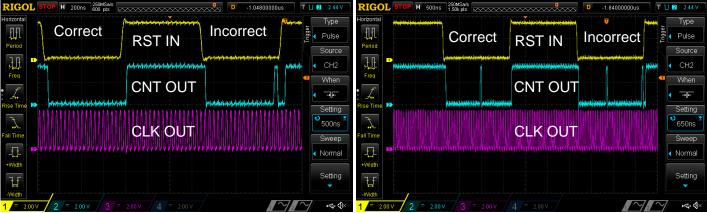
If the Counter Reset occurs at a time very close to a rising edge of the clock signal during clock signal generation (for example OSC operation), there is a possibility that the Counter Data of the Counter is reset incorrectly and the counter end signal (HIGH pulse) may appear faster than expected. This phenomena appears more frequently the higher the clock frequency is.

Synchronize the RESET input of the Counter with its CLK using 2 DFF cells as shown in the image below.

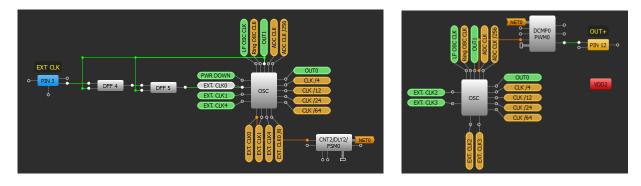
DCMP's OUT+ output may have a glitch when the input data is changed. This issue appears more frequently the higher DCMP clock is.

• Synchronize the data source clock with the DCMP clock source using 2 DFF cells as shown in the images below.

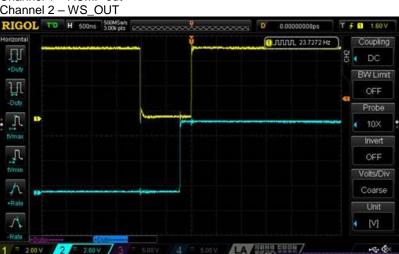
Channel 1 – ACMP out Channel 2 – WS_OUT

The output of the ACMP incorrectly goes low even when IN+ is greater than IN- if the RING OSC is active when the WS signal rises

Avoid using the RING OSC with the WS Controller, or add a filtering block on the ACMP output to filter out the glitch.
