# Application note

## DA9053 2-Wire Implementation

### AN-PM-003

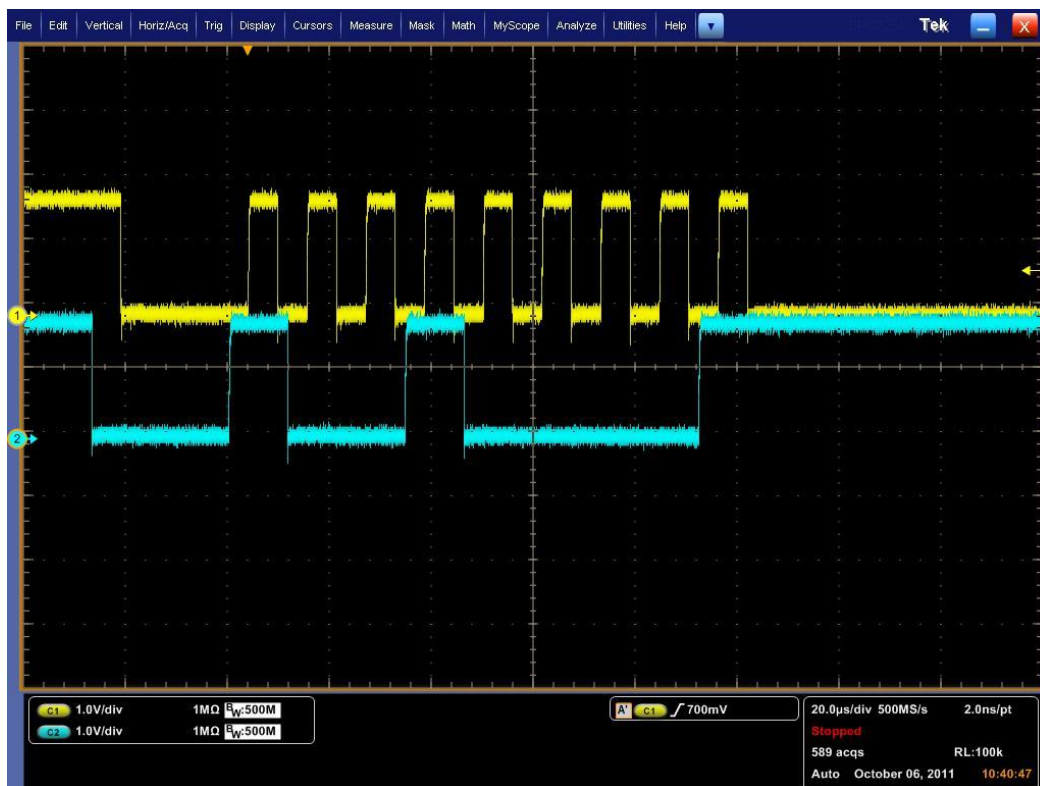
Figure 1: Diagram Example

Figure 1 below shows an example of the DA9053 responding with a NAK to the first message. As seen in the oscilloscope plot, the SDA line is high for the last clock cycle. (Yellow trace = SCL and blue trace = SDA.)

This can only happen as the DA9053 starts. As the IO supply rail for the I2C pull-ups rises, the 2-wire interface logic can detect an invalid condition due to the timing of the two signals. This happens because the I2C module is already out of reset as this power rail comes up. Once in the invalid condition, it can miss the next valid START condition on the 2-wire interface and treat it as the first bit of the message. If the power rail for the I2C pull-ups is present before the DA9053 comes out of RESET then the first I2C access will be correctly handled.

The workaround suggested will prevent a NAK on the first communication. It is assumed that the software will correctly deal with any other status messages from the I2C communication.

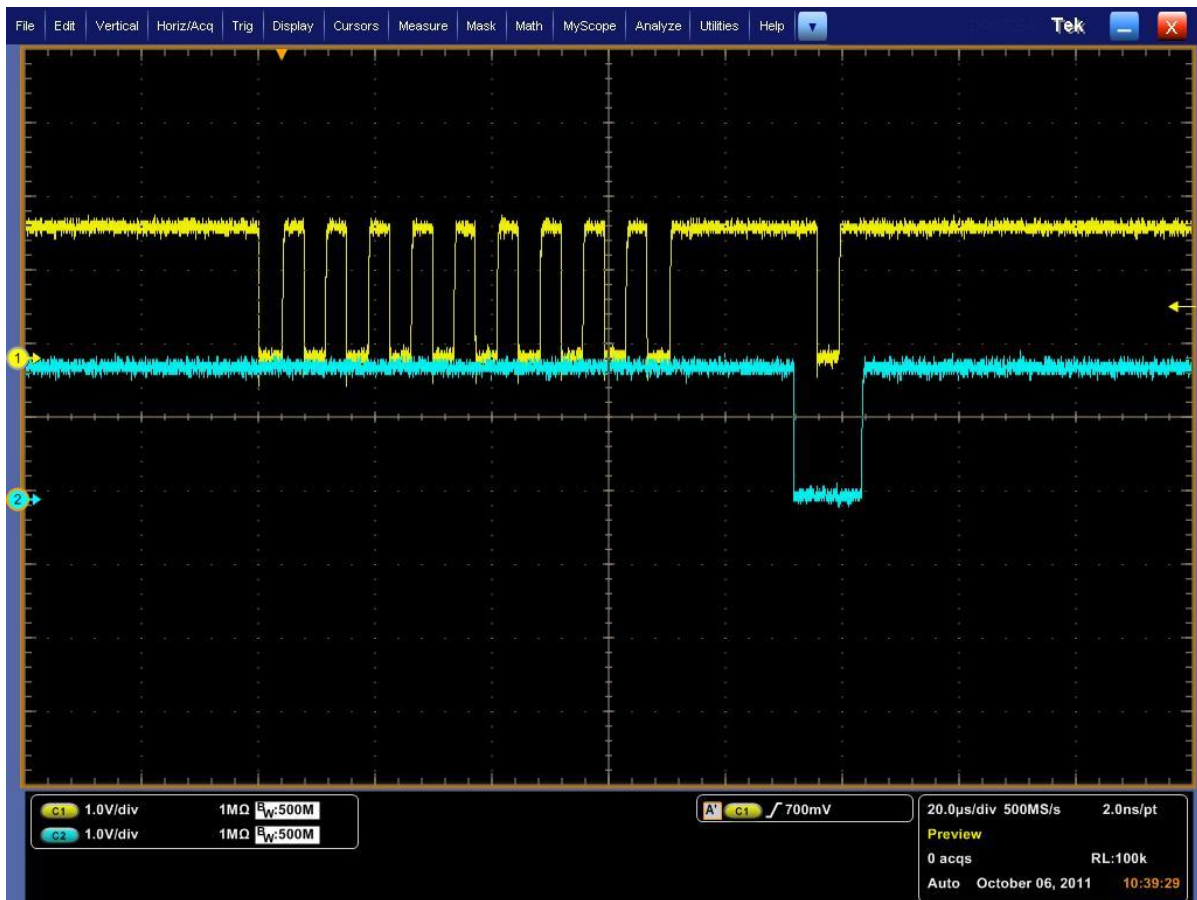
Figure 2: Fix for clearing the 2-wire SDA interface

This is the more serious situation whereby the invalid condition results in the DA9053 driving the SDA signal low. This will appear to the I2C host as though there is another master driving the bus and will lock the I2C bus.

This scenario can occur if the DA9053 shuts down during an I2C message whilst it is driving the bus low. If the DA9053 is shutdown in the middle of an I2C message but it is not driving SDA low, then upon the restart of the DA9053 it is possible that the first message will be answered with a NAK. This situation can arise because the I2C module in the DA9053 does not get reset: it therefore maintains its previous state and believes that it should still be driving the bus when it is switched back on. Therefore, once a shutdown command has been sent to the DA9053, no further traffic on the I2C bus should be allowed.

Both of the aforementioned issues can be prevented by applying a one-time software workaround before any I2C communication is attempted. The workaround is most usually placed in the boot loader.

As previously mentioned, the fix is to implement the same workaround that is described in the I2C specification. The procedure is:

1. Configure the I2C port pins to be GPIOs, preferably open-drain but push-pull is also acceptable.
2. Set the SCL line low then high nine times with at least 3  $\mu$ s between changes, for example: `udelay(3)`
3. Set SDA line low. Wait at least 3  $\mu$ s
4. Set SCL line low. Wait at least 3  $\mu$ s
5. Set SCL line high. Wait at least 3  $\mu$ s
6. Set SDA line high. Wait at least 3  $\mu$ s
7. Configure the pins to be under control of I2C controller.

The above procedure can be seen in [Figure 2](#) below.

The above implementation must be done before any attempt is made to communicate on the I2C bus.
