Application Note Shared IRQ Line Considerations

AN-PM-059

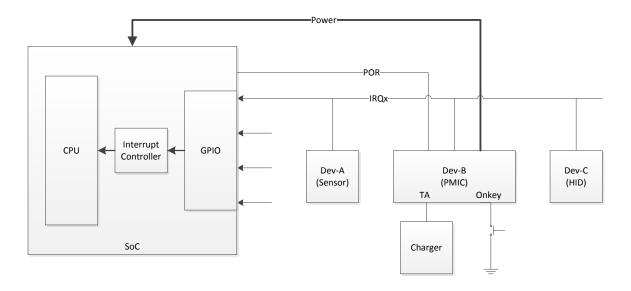
Figure 1: Shared Interrupt Line Block Diagram Example

Figure 1 shows a typical system where a Dialog PMIC delivers power to the SoC and shares the IRQx input with two other devices.

Each device has its own software interrupt service routine (ISR). These ISRs are called in turn by the operating system once the IRQx is received.

- If an ISR for either Dev-A or Dev-C is called before the PMIC device driver has been installed, the CPU may repeatedly call the Dev-A and/or Dev-C ISR as the interrupt line will still be held by Dev-B (PMIC).
