Errata SLG47105 CE-GP-003

This document contains the known errata for SLG47105 and the recommended workarounds.

Revision 1.2

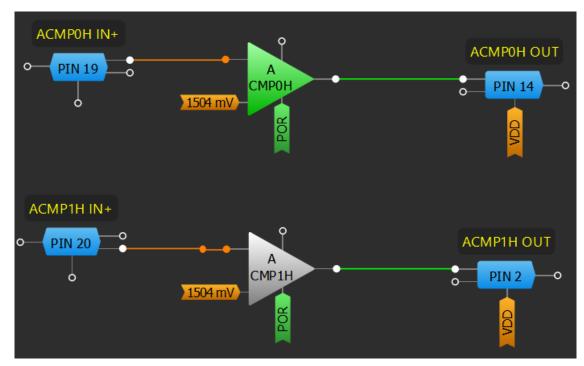
Figure 5: Testing Design

If using ACMPxH in with 32 mV or 64 mV hysteresis, ACMPxH output could be glitching when ACMPxH positive input (IN+) is close to the negative input (IN-). It can happen when V_{DD} higher 4.6 V and Vref is in a range from 1.344 V to 2.016 V for 32 mV hysteresis, and Vref is in a range from 1.376 V to 1.664 V for 64 mV hysteresis.

Channel 1 (yellow/top line) - PIN#19 (ACMP0H IN+) Channel 2 (light blue/2nd line) - PIN#14 (ACMP0H OUT)

Use the deglitch filter connected to the ACMPxH output.

Avoid conditions described in paragraph 3.3.2.

Decrease the reference to avoid conditions described in paragraph 3.3.2 at IN- and add the IN+ gain to keep the needed threshold.

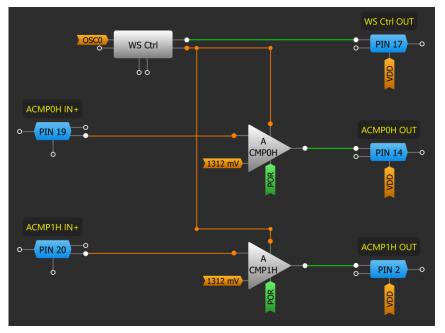
Figure 8: Testing Design

When WS Ctrl is used for controlling the power on/off of analog macrocells ACMPs for power saving, ACMPxH shows erroneous behavior for certain Vref selection. Vref transient settling error is observed for both WS Ctrl Wake time modes, Short wake time and Normal wake time (selections under CNT0 settings).

Channel 1 (yellow/top line) - PIN#19 (ACMP0H IN+)

1. If ACMP is used with WS Ctrl counter, CNT0, avoid conditions described in paragraph 3.4.2.

2. Decrease the reference to avoid conditions described in paragraph 3.4.2 at IN- and add the IN+ gain to keep the needed threshold.
